# BELZONA SOLVES CORROSION ISSUE ON SHEET EDGE ROOFING SECTIONS

ID: 7551

Customer Location: *Leisure Center, Fleetwood, England, UK*  
Application Date: *2016*

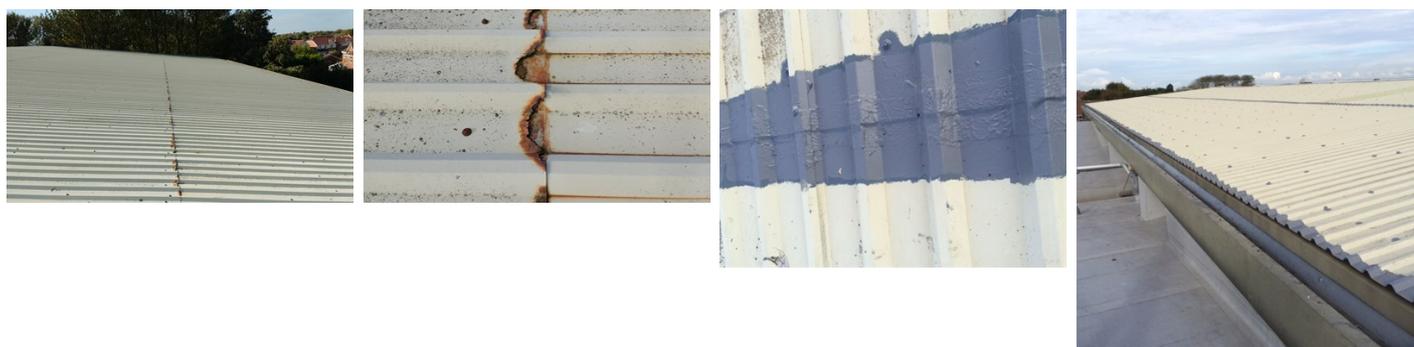
*The area is close to the coast making corrosion of metal a real problem on exposed areas of mild steel. This large metal roof was suffering significant sheet edge corrosion damage.*

- \* 1. Overview of roof area affected by sheet edge corrosion ,
- \* 2. Close of a badly damaged area ,
- \* 3. Close up of a repaired area ,
- \* 4. Overview of repaired roof area ,
- \* ,

The application was carried out in accordance with Belzona Know-How System Leaflet RPA-1.

The Customer required a quick and cost effective long term solution to the serious corrosion on the sheet ends. Failure to resolve the issue quickly would have lead to increased rates of corrosion and ultimately, failure to protect from water ingress. This would not only have been damaging to the infrastructure of the building but could have also lead to slip risks on wet areas of floor inside.
