Belzona repairs pitted engine cylinders

Industry: Marine
Application: ENC-Engines and Casings
Substrate: Cast iron
Products: * Belzona 1111 (Super Metal) ,

Customer Location: Shipyard, Glasgow, Scotland
Application Date: May 2017

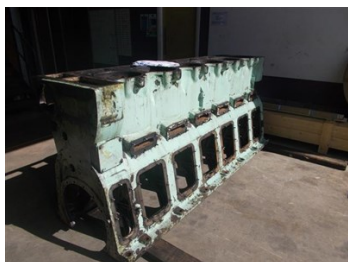
- * 1. The Engine block ,
- * 2. Close up of pitting damage ,
- * 3. Areas after grit blasting ,
- * 4. Application of Belzona 1111 ,

An engine block for a tugboat was found to have pitting around the cylinders.

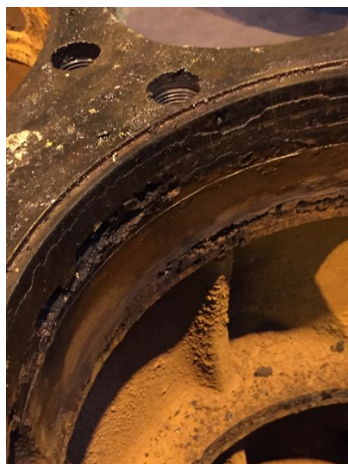
Weld repairs would be problematic & time consuming on this area. They would also not solve the original issue of corrosion.

The Belzona repairs rebuilt the lost metal with no risk of distortion or further damage to the casing. Belzona 1111 being corrosion resistant ensures a long term repair free from the original corrosion problems.
