Belzona repairs pitted engine cylinders

Industry: Marine
Application: ENC-Engines and Casings
Substrate: Cast iron
Products: * Belzona 1111 (Super Metal) ,

Customer Location: Shipyard, Glasgow, Scotland
Application Date: May 2017

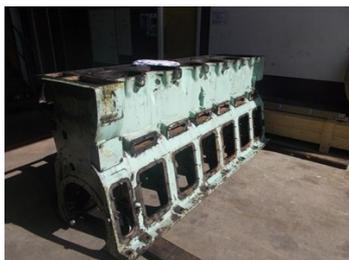
- * 1. The Engine block ,
- * 2. Close up of pitting damage ,
- * 3. Areas after grit blasting ,
- * 4. Application of Belzona 1111 ,

An engine block for a tugboat was found to have pitting around the cylinders.

Application was carried out in accordance with Belzona System Leaflet ENC-5 and ENC-6. The areas were grit blasted before Belzona 1111 was used to build up the pitted areas. The material was built up proud of the areas & then machined back on a large lathe.
