Belzona repairs pitted engine cylinders

Industry: Marine
Application: ENC-Engines and Casings
Substrate: Cast iron
Products: * Belzona 1111 (Super Metal) ,

Customer Location: Shipyard, Glasgow, Scotland
Application Date: May 2017

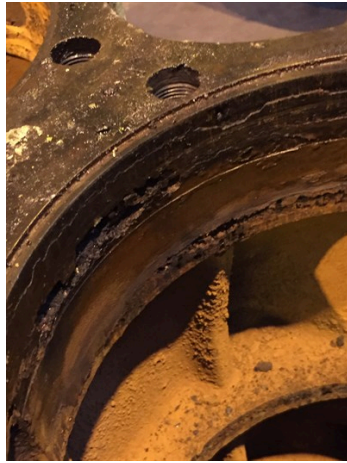
Weld repairs would be problematic & time consuming on this area. They would also not solve the original issue of corrosion.

- * 1. The Engine block ,
- * 2. Close up of pitting damage ,
- * 3. Areas after grit blasting ,
- * 4. Application of Belzona 1111 ,

An engine block for a tugboat was found to have pitting around the cylinders.
