BELZONA PROTECTS FLANGES FOR GAS WORKS

ID: 7554

Industry: Oil & Gas
Application: GSS-Gaskets, Seals and Shims
Substrate: Mild Steel Flange
Products: * Belzona 3411 (Encapsulating Membrane),

Customer Location: Glasgow, Scotland
Application Date: June 2017

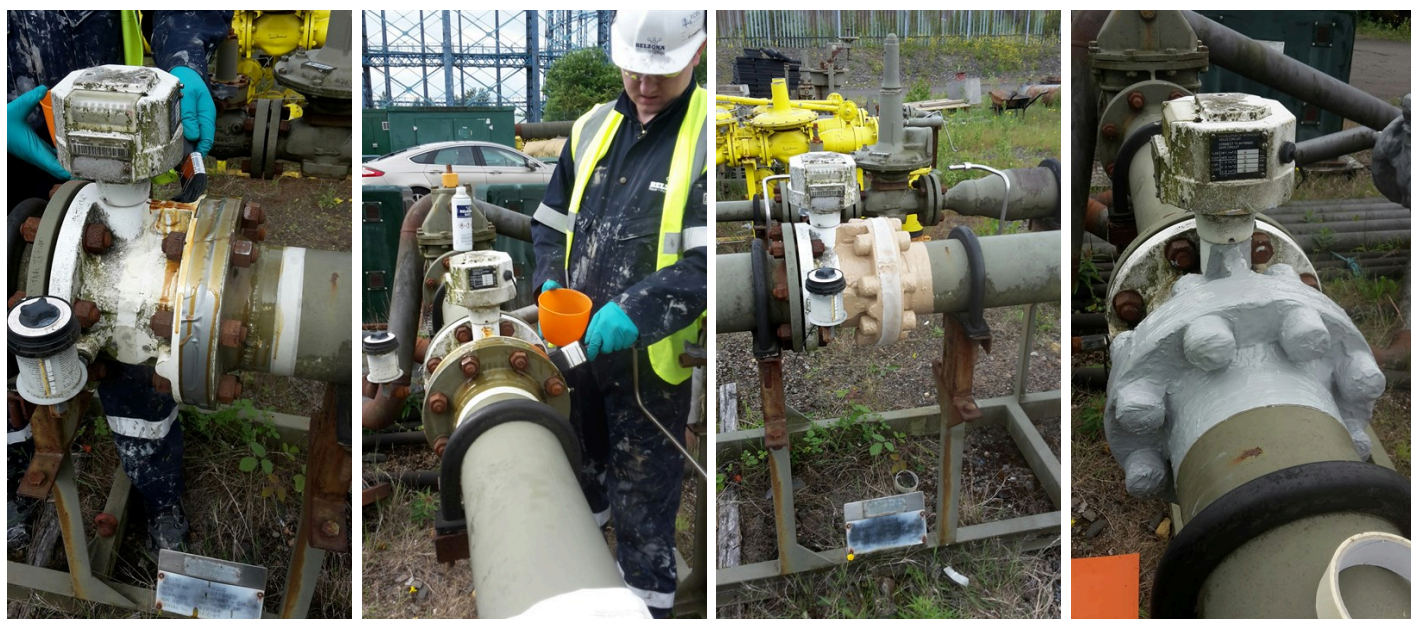
Photograph Descriptions

The Customer required a solution that would protect the flange from corrosion whilst still allowing access for inspection at a later date.

- * 1. Flange with void taped ,
- * 2. First coat during application ,
- * 3. First coat applied ,
- * 4. Second coat applied ,

A section of pipework had an exposed flange that was deemed to be susceptible to corrosion.

Application was carried out in accordance with Belzona Know-How System Leaflet GSS-11.

The Belzona solution allows the flange to be protected and then accessed when required for maintenance or inspection. Traditional painting of the flange would leave it inaccessible and may not completely encasulate the flange potentially allowing corrosion to still occur.
