RUBBER TRACK ON CRANE REPAIRED WITH BELZONA

ID: 756

Industry: *Buildings & Structures*
Application: *SHM-Solids Handling Machinery*

Customer Location: *Tank Fabricator, Kentucky*
Application Date: *November, 2005*

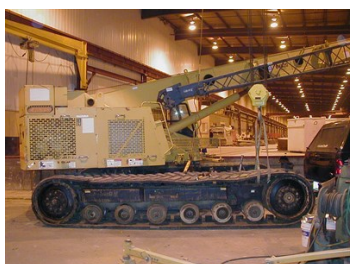
Track was ripped and would have to be replaced at a cost of \$7,000 without the repair.

- * Crane to be repaired ,
- * Prepared surface area ready to be repaired ,
- * Lifting strap used as reinforcement sheet ,
- * Completed bottom side of the application ,
