# RUBBER TRACK ON CRANE REPAIRED WITH BELZONA

ID: 756

Industry: *Buildings & Structures*  
Application: *SHM-Solids Handling Machinery*

Customer Location: *Tank Fabricator, Kentucky*  
Application Date: *November, 2005*

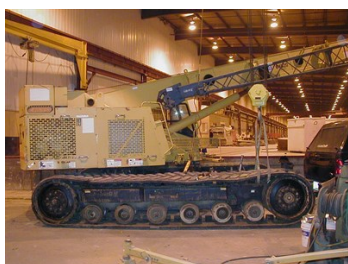
*Track was ripped and would have to be replaced at a cost of \$7,000 without the repair.*

- \* Crane to be repaired ,
- \* Prepared surface area ready to be repaired ,
- \* Lifting strap used as reinforcement sheet ,
- \* Completed bottom side of the application ,

Application was carried out in accordance with a modified version of Belzona Know-How System Leaflet SHM-1. Once the bottom repair was cured, the repaired area of the track was rotated to the top and the top was repaired without the reinforcing sheet using Belzona® 2211.
