# Belzona Repairs Turbine Exhaust Manifold

ID: 7561

Customer Location: Oil Field Operator, North Sea Norway  
Application Date: July 2013

Exhaust manifold piping.

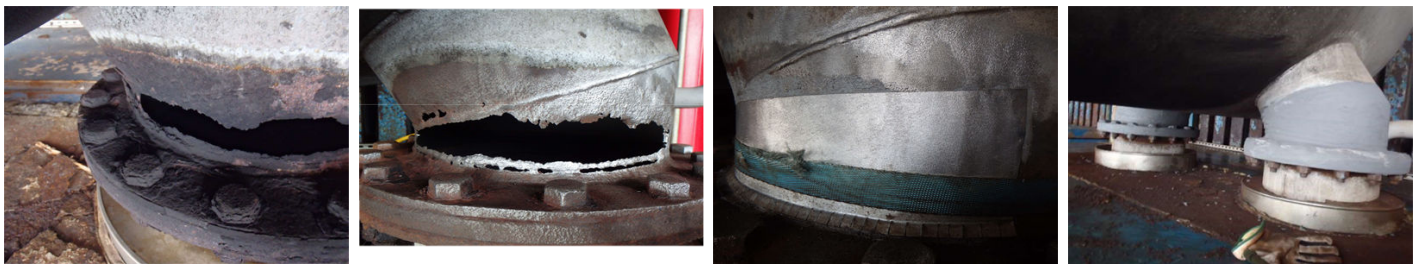
*Due to severe corrosion these pipes were leaking exhaust gases in an area close to personell gangways creating a safety hazard. Temperatures in the area reached 200 C.*

- \* 1. View of corroded area with through wall defect. ,
- \* 2. Surface preparation carried out. ,
- \* 3. Metal plate bonded in position ,
- \* 4. Completed application ,

Application was carried out in accordance with Belzona System Leaflet VPF-11. A thin plate was bonded to cover the defect area and to prevent ingress of product during application. Two consecutive layers of Belzona 1511 HT Metal reinforced with Belzona 9341 were applied leaving a solid composite wrap of 20mm thickness.
