# Belzona Protects River Back-Flow Valves

**Industry:** Water / Wastewater  
**Application:** VPF-Valves, Pipes and Fittings  
**Substrate:** Iron  
**Products:** \* Belzona 1111 (Super Metal) ,  
\* Belzona 5811 (Immersion Grade) ,  
\* Belzona 2211 (MP Fluid Elastomer) ,

**Customer Location:** Water management company, Slovakia  
**Application Date:** 2011

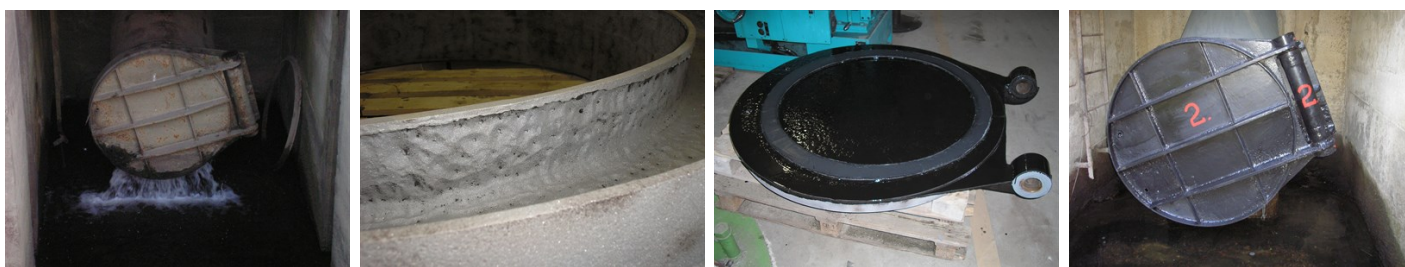
The valves suffered from erosion and corrosion through continued use. The valve was so badly damaged that it leaked even when shut.

- \* 1. Leaking back-flow valve before reconstruction. ,
- \* 2. Valve after blasting. ,
- \* 3. Shut off flap coated with Belzona 5811 and Belzona 2211. ,
- \* 4. Valve back in operation. ,

A Belzona repair avoiding costly repairs or replacement. This repair got the valve back in operation faster than traditional methods and with minimal disruption to the plant operation.
