Belzona Protects River Back-Flow Valves

Customer Location: Water management company, Slovakia

Application: VPF-Valves, Pipes and Fittings

River backflow valves at a water treatment plant.

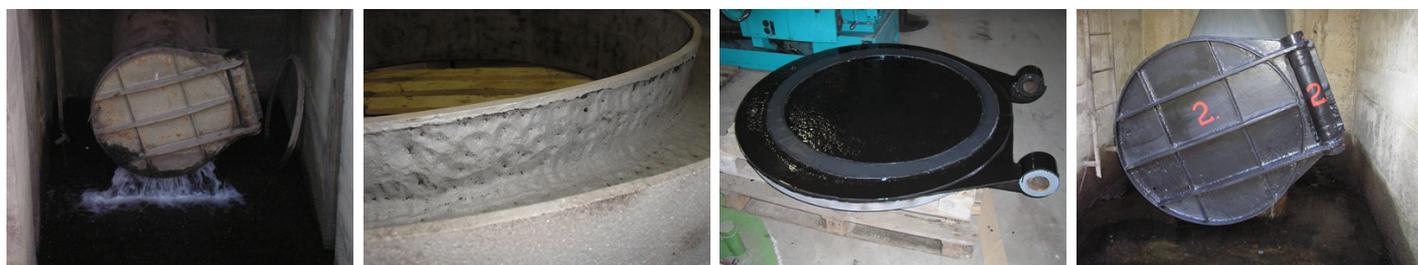
Photograph Descriptions

The valves suffered from erosion and corrosion through continued use. The valve was so badly damaged that it leaked even when shut.

- * 1. Leaking back-flow valve before reconstruction. ,
- * 2. Valve after blasting. ,
- * 3. Shut off flap coated with Belzona 5811 and Belzona 2211. ,
- * 4. Valve back in operation. ,

A Belzona repair avoiding costly repairs or replacement. This repair got the valve back in operation faster than traditional methods and with minimal disruption to the plant operation.
