Belzona Protects Settlement Tank

ID: 7565

Customer Location: Pharmaceutical Company, Slovakia
Application Date: 2010

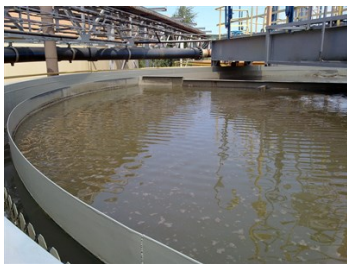
- * 1. Mixing Basin ,
- * 2. Extent of damage to the basin ,
- * 3. Blasting of the basin ,
- * 4. Completed application ,

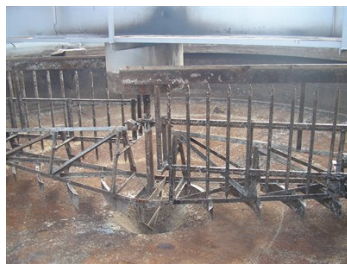
Erosion/corrosion damage was affecting the normal operation of the equipment

Damage to the tank and mixing equipment
