# Belzona Keeps The Cover On Annealing Oven

Customer Location: *Metallurgy Company, Slovakia*  
Application Date: *2011*

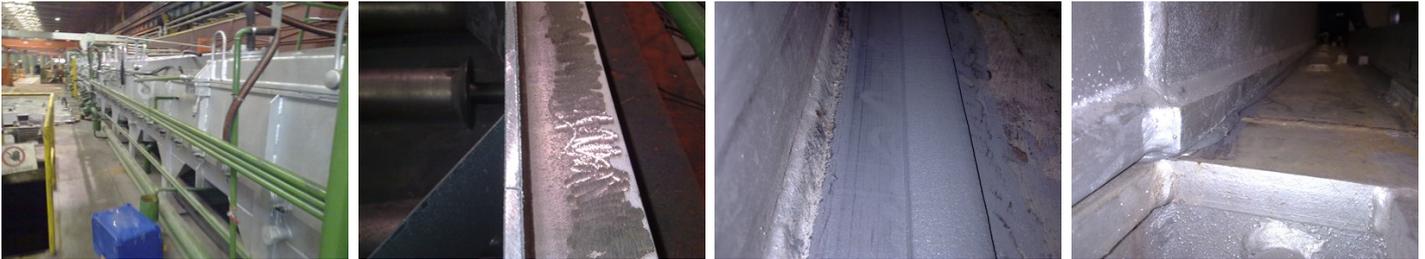
*The cover had distorted and did not sit correctly on the base and caused a CO2 leakage.*

- \* 1. Annealing ovens ,
- \* 2. Surface preparation ,
- \* 3. Belzona 1121 application ,
- \* 4. Cover replaced ,

Application was carried out in accordance with Belzona Know-How System Leaflet ENC - 7.

Using the Belzona solution allowed the original equipment to be used as a former, ensuring a perfect fit. Rebuilding in this way also meant the line was back up sooner than expected.
