# Belzona Repairs Pin Bush Housing

ID: 7568

Industry: Mining & Quarrying  
Application: MPT-Mechanical Power Transmission

Pin Bush Housing on mining power shovel.

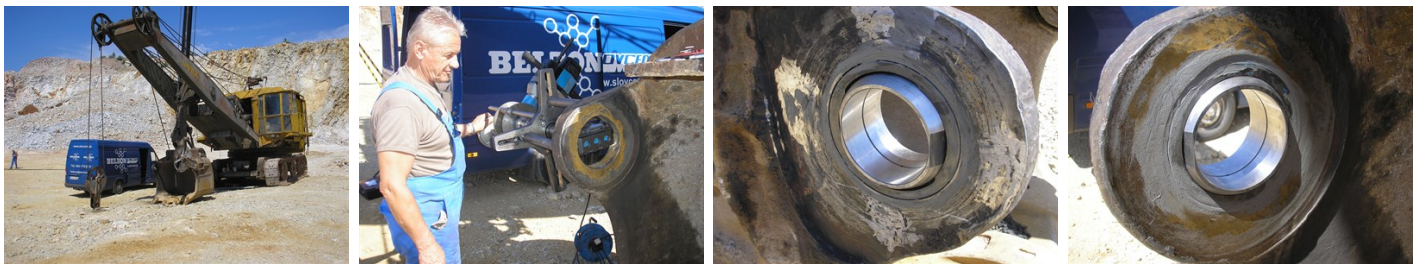
Housing had been damaged and worn down over time.

- \* 1. Mining Power Shovel. ,
- \* 2. Machining to proper diameter for Belzona 1111 application. ,
- \* 3. Bushing inserted. ,
- \* 4. Ready for service. ,

Application was carried out in accordance with Belzona Know-How System Leaflet MPT - 08.

Conventional welding repairs would have required long lead and repair times, leaving the equipment out of action for too long. Using the Belzona method the bush could be used as a former, ensuring a perfect fit, as well as repairing the shovel with minimal downtime.
