Belzona Repairs Manway Flange On Railway Tank

Industry: Chemical & Petrochemical
Application: TCC-Tanks and Chemical Containment Areas

Customer Location: Petrochemical Company, Slovakia
Application Date: 2011

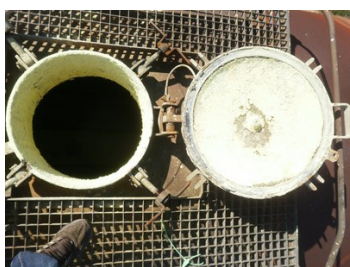
This tank was used to carry sulphuric acid, however, the manway area was not suitably protected so suffered from corrosion damage.

- * 1. Damaged manway ,
- * 2. Following grit blasting ,
- * 3. Completed Application ,
- * 4. Alternate view ,

Welding of a replacement flange was not an option for the customer. A rebuild and coat with Belzona solved the issue in a fraction of the time and cost, also preventing further damage from sulphuric acid.
