# BELZONA REPAIRS BROKEN RBC BASE

Customer Location: *Waste Water Treatment Plant in Oklahoma*

Application: *TCC-Tanks and Chemical Containment Areas*

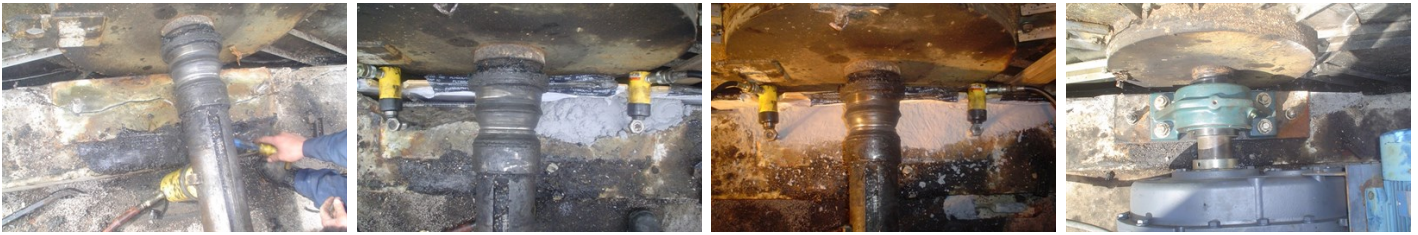
*While replacing the gearbox the customer broke the concrete base and anchors.*

\* Broken base , \* Area prepared & conditioned, backboard in place, anchors aligned, and filling with Belzona® 4111 , \* Base filled with Belzona® 4111. , \* Completed repair back in operation. ,

Concrete base for gearbox on the RBC (Rotating Biological Collector).

Application carried out in accordance with Belzona Know-How System Leaflet TCC-9.

The customer consulted with Belzona based upon previous successes. Traditional repair would have taken over a month with unacceptable downtime, and cost thousands of dollars. The Belzona repair was completed in a day.
