Concrete Bund Restored

ID: 7588

Application: TCC-Tanks and Chemical Containment Areas

Products: Belzona 4301 (Magma CR1 Hi-Build), Belzona 4311 (Magma CR1)

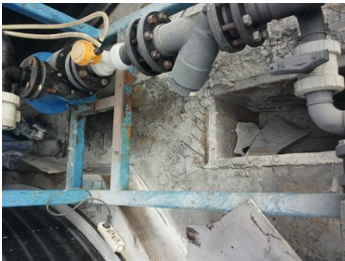
The acid attack had severely damaged the concrete over time, this lead to the acid not being

Damaged concrete basement

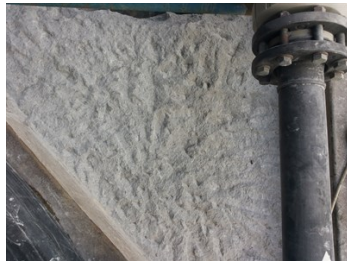
Surface preparation

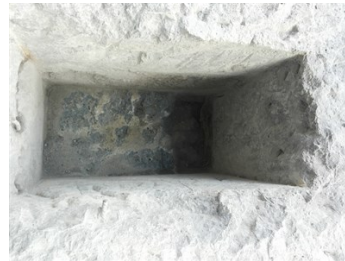
It was necessary to prepare firm surface

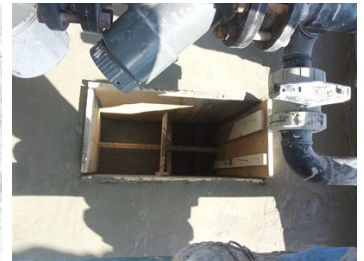
After Belzona application

Application was carried out in accordance with Belzona Know-How System Leaflet TCC-15.

Originally was the concrete basement was unprotected. After this Belzona reconstruction was customer very satisfied with resistance of this material.
