# BELZONA REPAIRS RBC SHAFT

Customer Location: *Waste Water Treatment Plant,  
Oklahoma USA*

Application: *MPT-Mechanical Power Transmission*

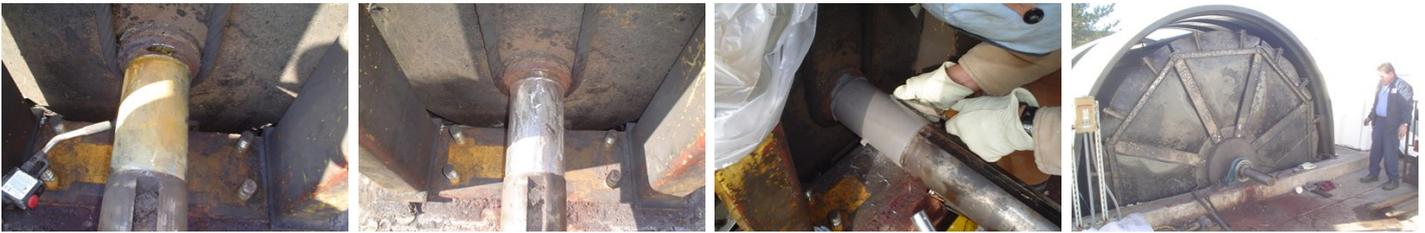
*The bearing failed, damaging the shaft.*

- \* Damaged shaft ,
- \* Shaft prepared and ready for Belzona ,
- \* After curing former removed and extrusions filed down ,
- \* The RBC is resealed and back in service ,

Application carried out in accordance with Belzona Know-How System Leaflet MPT-2.

Alternative repair would be to dry the RBC out over a 3 week period, remove all the media, then call in a machinist to repair the shaft before reinstalling the RBC and media. Very time consuming and expensive. The repair was done using about \$150 worth of Belzona in one day. Application was well over two years old when checked in March, 2008. Four other RBC shafts have been repaired in this plant in the same way since then.
