Pump protection

Industry: *Chemical & Petrochemical*
Application: *CEP-Centrifugal Pumps*
Substrate: *Cast Iron*
Products: *Belzona 1812, Belzona 1391*

Customer Location: *Chemical company, Slovakia*
Application Date: *May 2018*

Problem
Erosion/ corrosion

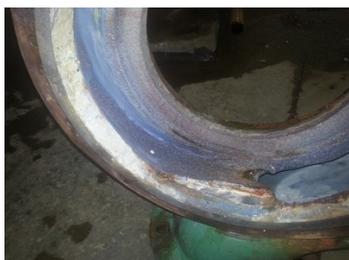
Damaged internal surface of the pump.

Size and quantity of solid parts in salt brine caused pump destruction.

Original coating protection - rubber was destroyed in short time. Combination of products Belzona 1812 and 1391 was good solution was this customer. Titanium pumps, which are able to work in these conditions, are very expensive.

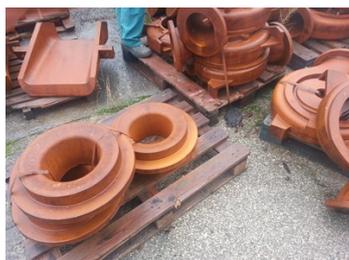
The customer uses a large number of pumps in production.

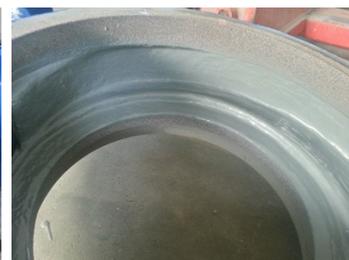
Repair detail with Belzona 1812 and 1391 products

Application was carried out in accordance with Belzona Know-How System Leaflet CEP - 3
