Pump protection

ID: 7590

Industry: *Chemical & Petrochemical*
Application: *CEP-Centrifugal Pumps*
Substrate: *Cast Iron*
Products: *Belzona 1812, Belzona 1391*

Customer Location: *Chemical company, Slovakia*
Application Date: *May 2018*

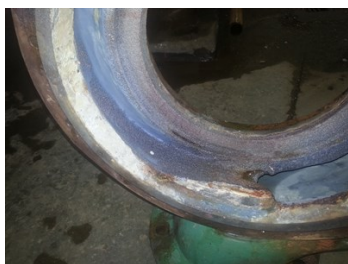
Erosion/ corrosion

Damaged internal surface of the pump.

Size and quantity of solid parts in salt brine caused pump destruction.

Original coating protection - rubber was destroyed in short time. Combination of products Belzona 1812 and 1391 was good solution was this customer. Titanium pumps, which are able to work in these conditions, are very expensive.

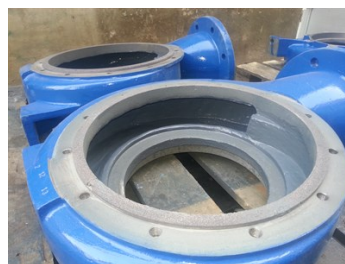
The pump is ready for shipment to the customer.

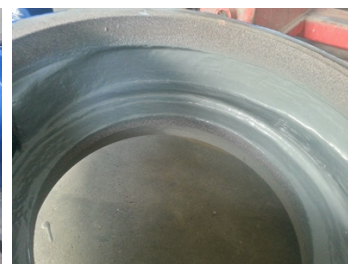
Repair detail with Belzona 1812 and 1391 products

Application was carried out in accordance with Belzona Know-How System Leaflet CEP - 3
