# Chemical tanks given support with chocking compound

ID: 7592

Application: GSS-Gaskets, Seals and Shims

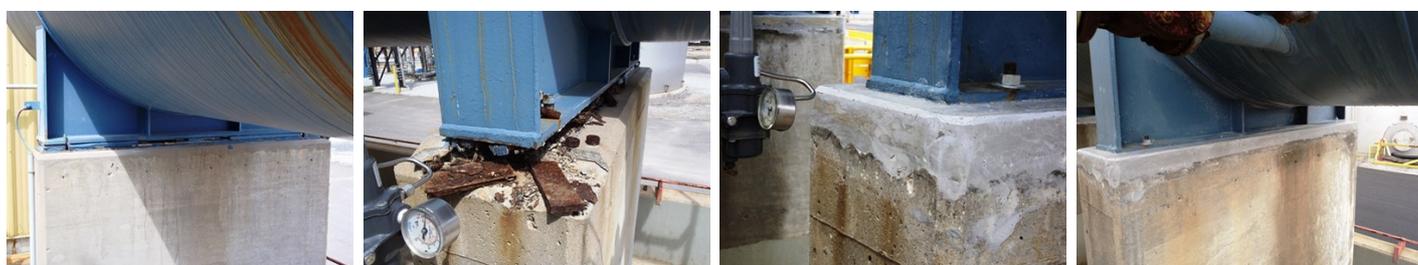
## Photograph Descriptions

Three 96" dia. x 20' long bulk sulfuric acid and caustic storage tanks located in the water treatment plant. The 1.5" - 2" thick existing grouting system between the steel supports and the concrete base has become broken and dis-bonded. This has exposed the wooden leveling shims. The wooden shims have become rotten over time and require removal and replacement.

\* 1. Failed existing grout between tank base and concrete base 2. Removal of rotten timber packing and shim material 3. Installed Belzona 7111 4. Installed Belzona 7111 ,

The application followed the Belzona system leaflet GSS-13. The process first involved the removal of the wooden shims and chip out of any loose chocking material and damaged concrete base. New anchors and shims were installed to secure the tank to the base. A temporary former and pouring box was created to surround the concrete base. Application of Belzona 8411 Release Agent was applied to the wooden former and anchor bolts. Temperature of the steel substrate and the IFU was used to calculate the solidifier reduction level by using the graph #2 (steel & concrete). The product was poured into the former and allowed to flow under the tank supports and fill all voids and cavities. Once cured the forms were removed and a chamfer was ground on the edge of the Belzona 7111.
