# Bed plate of pressing machine rebuilt with Belzona

Industry: General Industry  
Application: ENC-Engines and Casings  
Substrate: Steel  
Products: \* Belzona 1111 (Super Metal) ,

Customer Location: Rubber producer, Slovakia  
Application Date: 2014

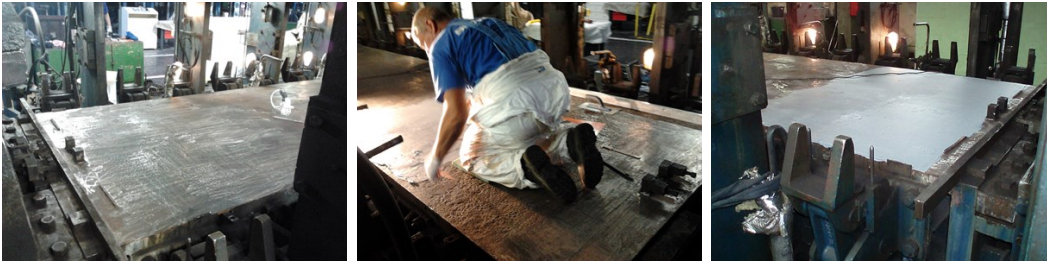
*Hydrochloric acid condensed from the process destroyed the base plate of the pressing machine.*

- \* 1. Surface preparation ,
- \* 2. Belzona 1111 being applied ,
- \* 3. The plate ready for leveling by grinding ,

Application was carried out in accordance with Belzona Know-How System Leaflet ENC-7. After Belzona 1111 application it was necessary to level the plate by grinding.

Welding of this damage would take a long time, so rebuilding with Belzona 1111 was much better for customer. It was not first repair like this, first repair was done in 2013 and customer was satisfied with the outcome.
