Belzona Repairs Blower Wheel

Application: *SHM-Solids Handling Machinery*

Customer Location: *Cement Producer, Slovakia*

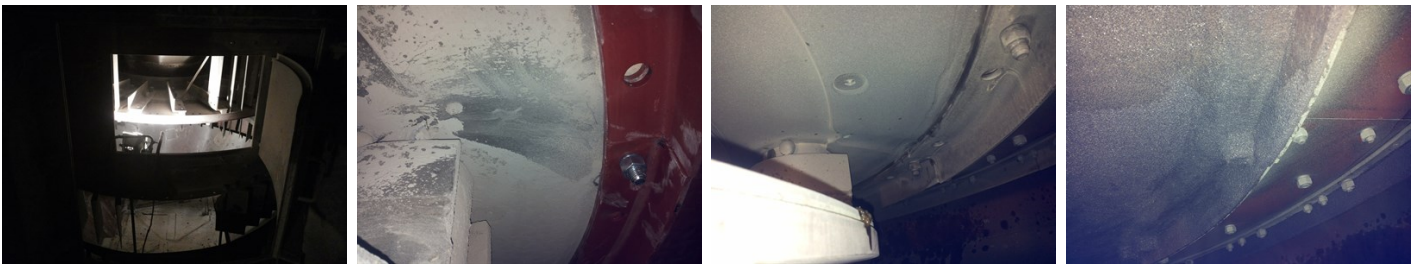
Where the cement hits some areas of the blower they experienced severe abrasion and erosion. They required an alternative to welding fresh metal plates to reinstate lost material.

- * 1. Blower. ,
- * 2. Damaged areas. ,
- * 3. After grit blasting. ,
- * 4. Belzona 1811 application. ,

In some cases it was not possible to weld new plates as substrate was too thin and in difficult to reach areas. Belzona protection was a faster and more effective solution. It is also easier to maintain in future.
