Belzona Repairs Air Pipe Distributor

ID: 7596

Customer Location: Cement Producer, Slovakia
Application Date: 2016

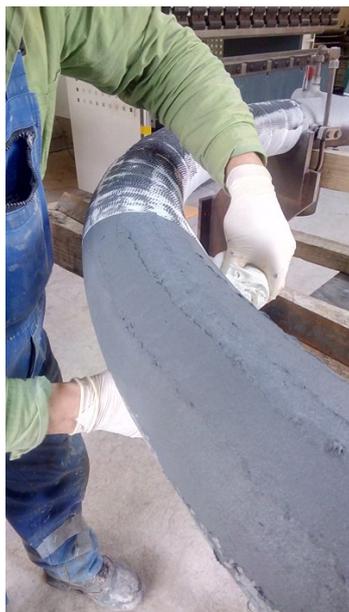
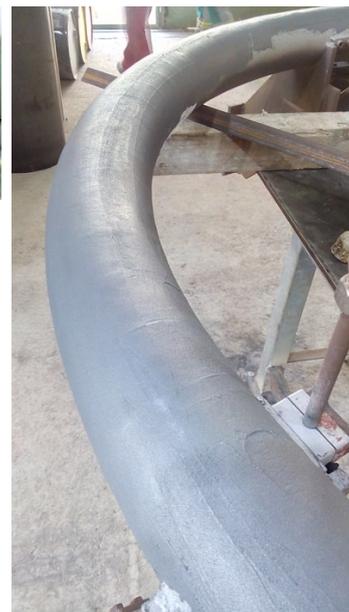
Whilst the system was offline, condensed gases created corrosion (deep 3 mm) on the DN 125 air pipe distributor.

- * 1. Air distributor after blasting. ,
- * 2. Belzona 1111 plus reinforcement tape. ,
- * 3. Full extent of the pipe. ,
- * 4. Belzona application complete. ,

Application was carried out in accordance with Belzona Know-How System Leaflet VPF - 11.

Due to the size and complexity of the pipe, there was an extremely long lead time on a replacement, as well as considerable costs. The Belzona repair restored strength to the pipe and prevented future corrosion damage.
