Belzona Repairs Air Pipe Distributor

ID: 7596

Customer Location: Cement Producer, Slovakia
Application Date: 2016

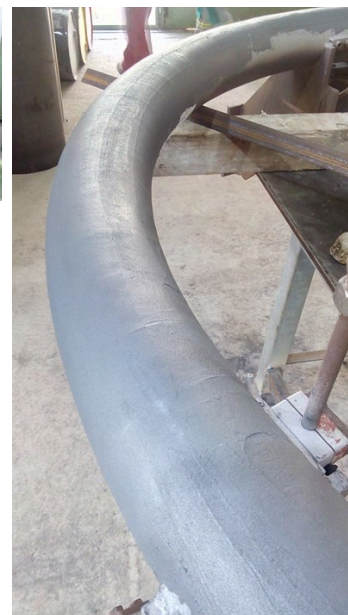
Photograph Descriptions

Whilst the system was offline, condensed gases created corrosion (deep 3 mm) on the DN 125 air pipe distributor.

- * 1. Air distributor after blasting. ,
- * 2. Belzona 1111 plus reinforcement tape. ,
- * 3. Full extent of the pipe. ,
- * 4. Belzona application complete. ,

Application was carried out in accordance with Belzona Know-How System Leaflet VPF - 11.

Due to the size and complexity of the pipe, there was an extremely long lead time on a replacement, as well as considerable costs. The Belzona repair restored strength to the pipe and prevented future corrosion damage.
