# Belzona Repairs Air Pipe Distributor

ID: 7596

Customer Location: Cement Producer, Slovakia  
Application Date: 2016

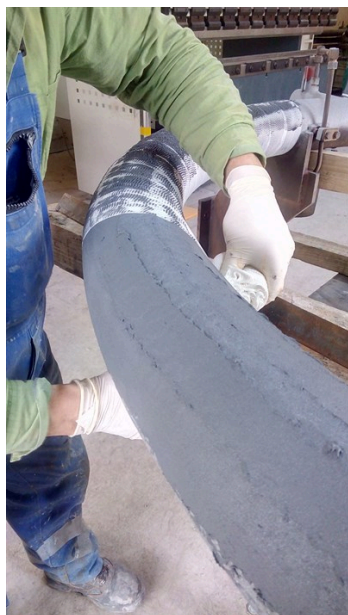
Whilst the system was offline, condensed gases created corrosion (deep 3 mm) on the DN 125 air pipe distributor.

- \* 1. Air distributor after blasting. ,
- \* 2. Belzona 1111 plus reinforcement tape. ,
- \* 3. Full extent of the pipe. ,
- \* 4. Belzona application complete. ,

Due to the size and complexity of the pipe, there was an extremely long lead time on a replacement, as well as considerable costs. The Belzona repair restored strength to the pipe and prevented future corrosion damage.
