Belzona repairs Mould flange

Customer Location: *Aluminium producer, Slovakia,*
Application Date: *2014*

Mould used in production of anodes.

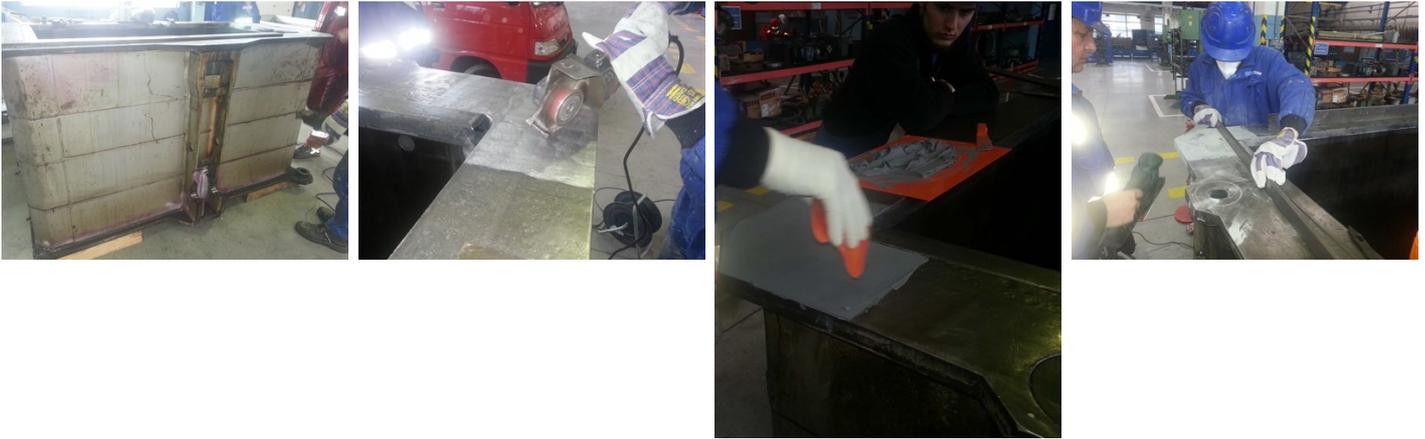
Photograph Descriptions

During mould manipulation workers damaged the flange leading to loss of critical dimension.

- * 1. Mould has massive construction ,
- * 2. Surface preparation ,
- * 3. Belzona 1111 application ,
- * 4. Final grinding to achieve correct level ,

Application was carried out in accordance with Belzona Know-How System Leaflet ENC-7

Because the mould has massive construction it was not possible to bend sealing face back. Welding would have taken a long time. Repair with Belzona 1111 was done very quickly.
