Corrosion of the steel construction

Industry: Chemical & Petrochemical
Application: TCC-Tanks and Chemical Containment Areas
Substrate: Carbon steel
Products: Belzona 5811 (Immersion Grade)

Customer Location: Polyethylene foils producer, Slovakia
Application Date: May 2015

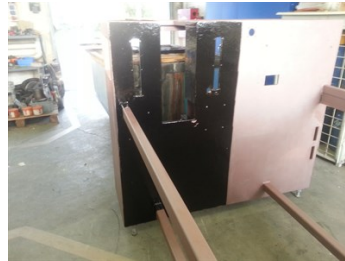
Technical chemicals caused damaging

Construction after blasting

Coating selected impacted areas by Belzona 5811
