Belzona Repairs Flange Ring On HCL Tank

Application: TCC-Tanks and Chemical Containment Areas

Customer Location: District Heating Plant, Slovakia

Tank for storing 34% HCL.

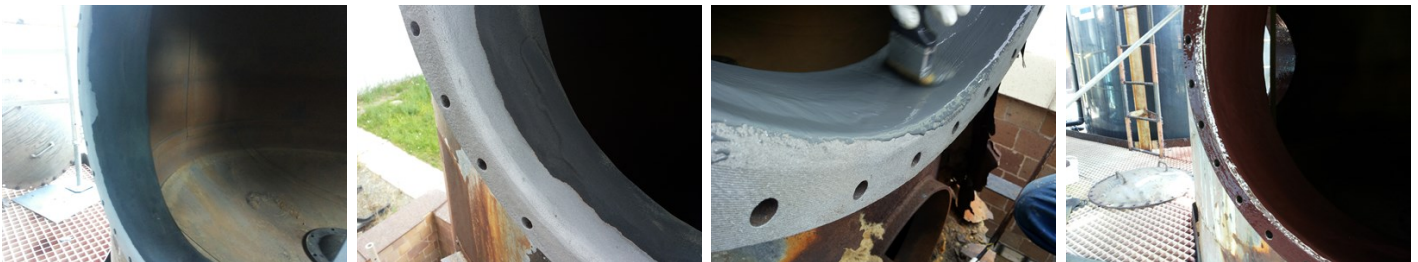
Photograph Descriptions

After a long lay-off period the area near the flange had suffered from corrosion and mechanical damage. The rubber coating inside was good, but problem was close to gathering ring.

- * 1. Damaged flange ,
- * 2. After blasting ,
- * 3. First coat of Belzona 4311 ,
- * 4. Completed Belzona application ,

Application was carried out in accordance with Belzona Know-How System Leaflet TCC - 3

Creating a new rubberling for this area would have been technically difficult and time-consuming. The Belzona solution provides ongoing protection and was done in a short timeframe.
