# Belzona repair the welding aluminum seams

Industry: *Power*  
Application: *SOS-Ships and Offshore Structures*

Customer Location: *Slovakia, heating plant*  
Application Date: *2014*

Substrate: *Aluminium alloy*  
Products: *\* Belzona 2211 (MP Hi-Build Elastomer) ,*  
*\* Belzona 2131 (D&A Fluid Elastomer) ,*

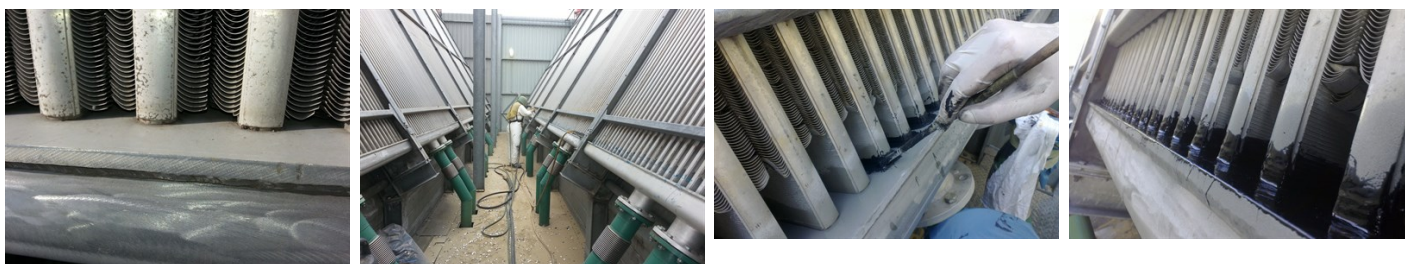
*Cracks in the aluminium*

- \* 1. Damaged vacuum condenser ,
- \* 2. Blasting ,
- \* 3. Belzona 2211 application ,
- \* 4. After Belzona 2131 application ,

Vacuum condenser has aluminium construction. Source of the cracks on the welding seams is mechanical movement from temperature differences.

The application was carried out in accordance with a modified version of Belzona Know-How System Leaflet SOS-21.

Cracks mean vacuum lost and decreasing efficiency of all devices. Local welding did not work, also crackled. After some test period with Belzona products customer made decision to applicate Belzona product on all devices.
