Plate heat exchangers repaired with Belzona

ID: 7603

Application: VPF-Valves, Pipes and Fittings

Customer Location: University, Slovakia,

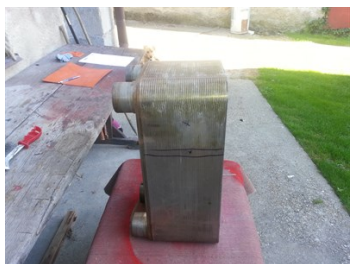
After 8 years operation some leaks appeared due to corrosion.

- * 1. Damaged exchanger ,
- * 2. Surface preparation completed using an MBX Bristle Blaster ,
- * 3. Belzona 1212 and reinforcement tape applied ,
- * 4. Ready for operation ,
