# Plate heat exchangers repaired with Belzona

ID: 7603

Customer Location: University, Slovakia,  
Application Date: 2016

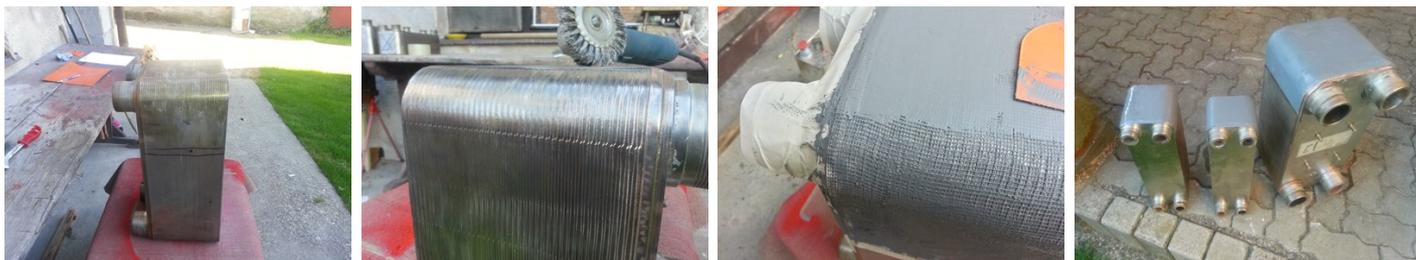
## Photograph Descriptions

After 8 years operation some leaks appeared due to corrosion.

- \* 1. Damaged exchanger ,
- \* 2. Surface preparation completed using an MBX Bristle Blaster ,
- \* 3. Belzona 1212 and reinforcement tape applied ,
- \* 4. Ready for operation ,

Application was carried out in accordance with modified Belzona Know-How System Leaflet VPF 11

Welding of these damaged parts is extremely difficult. Belzona solution was quick and with perfect quality and no risk of causing additional damage or distortion.
