COOLING TOWER COATED WITH BELZONA® 5811 BY SPRAY

ID: 761

Customer Location: *Automotive Plant in Southern Ontario*
Application Date: *February, 2006*

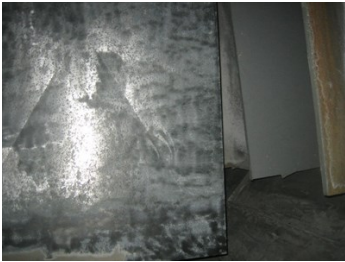
- * Previous coating easily blasted off. , * Application Pump made ready. , * Material spray applied to 700 square feet very quickly. ,
- * Door closures were also coated and job completed. ,
