# COOLING TOWER COATED WITH BELZONA® 5811 BY SPRAY

ID: 761

Customer Location: *Automotive Plant in Southern Ontario*  
Application Date: *February, 2006*

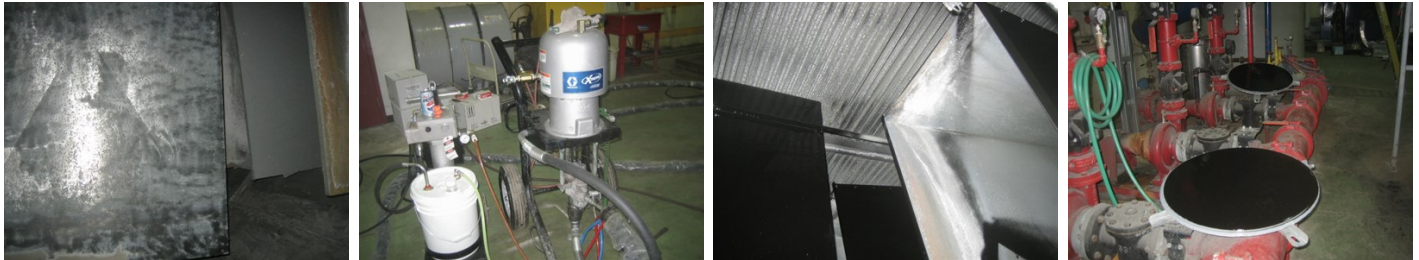
*Previous coating was coming off before going into service.*

- \* Previous coating easily blasted off. ,
- \* Application Pump made ready. ,
- \* Material spray applied to 700 square feet very quickly. ,
- \* Door closures were also coated and job completed. ,

Application was carried out in accordance with Belzona Know-How System Leaflet HEX-12. Spray applied with Graco Extreme 68-1 Pump and heated lines with Viscon heater.
