Belzona repairs joints in concrete

Customer Location: Furniture production plant, Slovakia,
Application Date: 2015

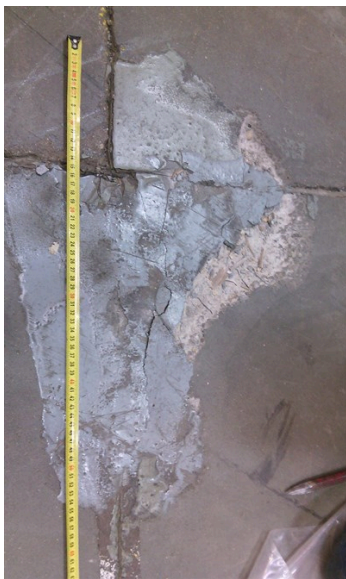
Heavy fork lift truck traffic destroyed joint nosings.

- * 1. Damaged dilatation joint ,
- * 2. Repair in progress ,
- * 3. Belzona 2211 application ,
- * 4. Joints ready for work ,
