Belzona Extends the Life of Mixing Blades

Customer Location: Plaster Production Factory, Slovakia

Application: SHM-Solids Handling Machinery

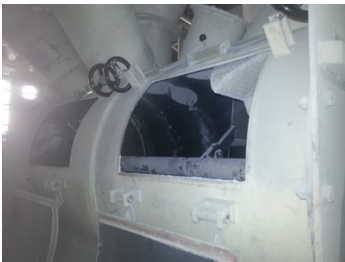
Heavy erosion, without any protection a mixing anchor lasted about 3 months.

- * 1. Mixing machine ,
- * 2. Belzona 1812 and 9811 application ,
- * 3. Anchor after 12 months mixing ,
- * 4. Anchors after 4 years in service ,

Application was carried out in accordance with Belzona System Leaflet SHM-7.

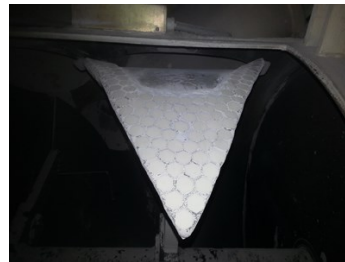
Conventional welding of hard steel wear plates was very complicated. After a 6 month trial with Belzona protection there was no damage, after this the customer ordered all future anchors to use the Belzona protection system.
