Large storage tank protected with Belzona

ID: 7618

Customer Location: Petrochemical company, Slovakia
Application Date: 2015

Crude oil storage tank

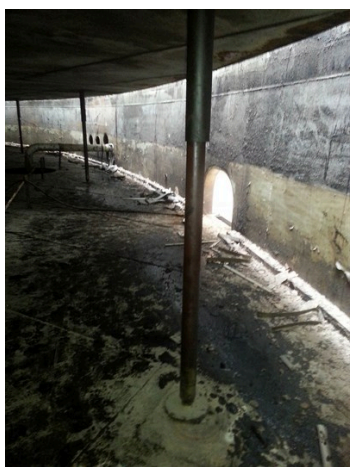
The tank had been in service for twenty years and was suffering extensive corrosion damage

- * 1. Tank after 20 years. ,
- * 2. Blasting of the basin ,
- * 3. Visible damages after blasting ,
- * 4. Belzona 5811 coating applied in 2 layers ,
