ELEVATOR PIT LEAK SEALED WITH BELZONA

ID: 7639

Industry: Buildings & Structures
Application: FPA-Floor Problem Areas
Substrate: Concrete

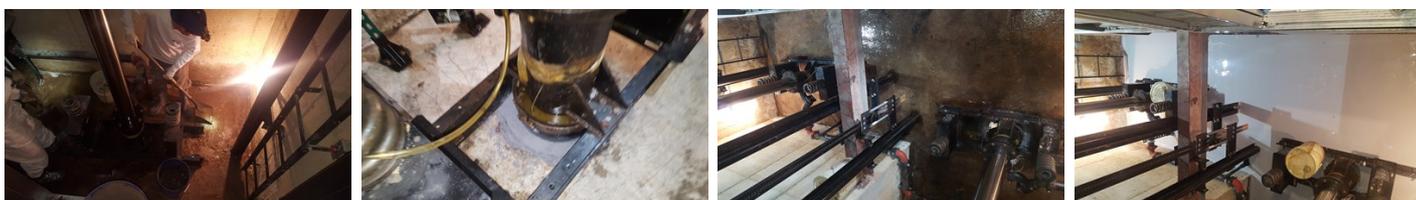
Photograph Descriptions

The concrete pit of an elevator shaft had begun to deteriorate and allow water to enter the pit, damage the substrate and corrode the supporting steel structures.

- * 1. Original condition of the elevator shaft. Full of muck, mud, oil, and standing water. ,
- * 2. Belzona 4131 used to create a permanent seal around the elevator drive shaft. ,
- * 3. Belzona 4151 applied as a basecoat. ,
- * 4. Belzona 5231 used as a topcoat. ,

All surface contaminants were removed and the substrate was power washed and dried. Once dried, the surface was prepared to application requirements and Belzona 4131 was used to rebuild any failures and create a permanent seal around the elevator drive shaft hole. Then a base coat of Belzona 4151 was used to cover the entire floor, sump, and 2" up the walls. A topcoat of Belzona 5231 was then applied within the overcoat parameters of Belzona 4151 and left to cure overnight.
