Belzona Installs a New Expansion Joint for a Smooth Ride at an Operating Room

ID: 7640

Customer Location: *Florida, USA*
Application Date: *December, 2017*

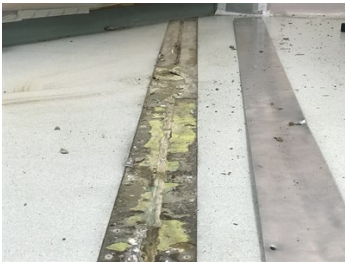
Existing solution of a thin stainless steel cover has failed in the OR (operating room), client was seeking a new fix to an old and ongoing problem for this older building.

- * 1. The stainless steel cover removed exposing the failing expansion joint material. ,
- * 2. Scarifying one side to even the joint which was off in some areas by a 1/4 of an inch thick. ,
- * 3. Finished application. ,
- * 4. Custom 1/8" thick steel bridge fabricated specific to this application to allow the OR unit to re-open during the curing process. ,

Client had a failing expansion joint covered by a thin stainless steel plate. Within a year the new stainless steel cover had bowed causing medical carts to tip over, or staff to trip and possibly fall.

The application was carried out in accordance with a modified version Belzona System Leaflet FPA-6 for replacing expansion joint sealant.
