Belzona Installs a New Expansion Joint for a Smooth Ride at an Operating Room

ID: 7640

Customer Location: *Florida, USA*
Application Date: *December, 2017*

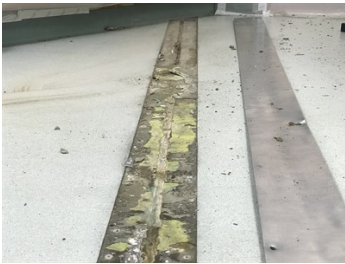
- * 1. The stainless steel cover removed exposing the failing expansion joint material. ,
- * 2. Scarifying one side to even the joint which was off in some areas by a 1/4 of an inch thick. ,
- * 3. Finished application. ,
- * 4. Custom 1/8" thick steel bridge fabricated specific to this application to allow the OR unit to re-open during the curing process. ,

Client had a failing expansion joint covered by a thin stainless steel plate. Within a year the new stainless steel cover had bowed causing medical carts to tip over, or staff to trip and possibly fall.

The application was carried out in accordance with a modified version Belzona System Leaflet FPA-6 for replacing expansion joint sealant.
