# Belzona Installs a New Expansion Joint for a Smooth Ride at an Operating Room

ID: 7640

**Customer Location:** Florida, USA  
**Application Date:** December, 2017

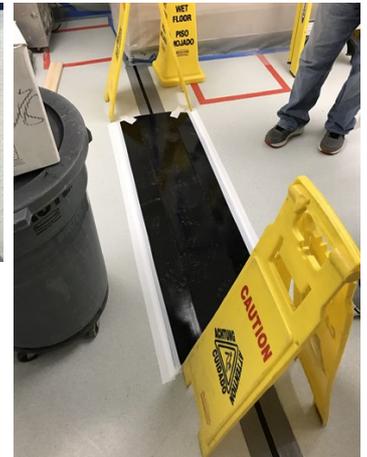
Existing solution of a thin stainless steel cover has failed in the OR (operating room), client was seeking a new fix to an old and ongoing problem for this older building.

- \* 1. The stainless steel cover removed exposing the failing expansion joint material. ,
- \* 2. Scarifying one side to even the joint which was off in some areas by a 1/4 of an inch thick. ,
- \* 3. Finished application. ,
- \* 4. Custom 1/8" thick steel bridge fabricated specific to this application to allow the OR unit to re-open during the curing process. ,

Client had a failing expansion joint covered by a thin stainless steel plate. Within a year the new stainless steel cover had bowed causing medical carts to tip over, or staff to trip and possibly fall.

The application was carried out in accordance with a modified version Belzona System Leaflet FPA-6 for replacing expansion joint sealant.

Alternative was to have another stainless steel cover reinstalled, only to have it fail after a year. The permanent solution was a "Smooth Ride" expansion joint with Belzona products which will save the hospital unnecessary downtime by having a smooth surface to ensure no more spills, trips and falls. The custom fabricated a steel bridge to allow the OR unit to re-open the following day once the special containment was removed and the area sterilized. The cold floor of this OR unit made the curing process a lot slower and having the custom fabricated bridge was the only way this application was able to be performed.
