# Oxygenation Tank Rebuilt and Protected for Years to Come

ID: 7642

Industry: *Water / Wastewater*  
Application: *TCC-Tanks and Chemical Containment Areas*

Oxygenation tank at a wastewater plant. Customer required protection of this tank for years to come. Time was of the essence because rainy season was very close.

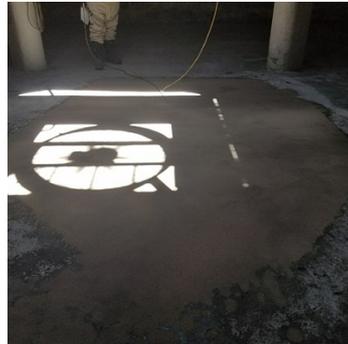
*The tank had not had protection for years, and as a result the concrete walls and floors were in a bad shape. Some sections showed erosion as deep as 3'. Large mixer blades had caused a severe erosion the tanks' structure. The time was of the essence because of the rainy season.*

- \* Damaged Concrete. ,
- \* Concrete rebuilt with Belzona 4124. ,
- \* Concrete coated with Belzona 5811. ,
- \* Belzona Alumina Tiles System installed: Belzona 5811 as a base coat, Belzona 9811 and Belzona 1812 (as a grouting compound). ,
