Oxygenation Tank Rebuilt and Protected for Years to Come

ID: 7642

Oxygenation tank at a wastewater plant. Customer required protection of this tank for years to come. Time was of the essence because rainy season was very close.

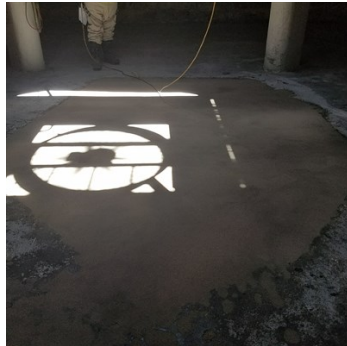
The tank had not had protection for years, and as a result the concrete walls and floors were in a bad shape. Some sections showed erosion as deep as 3'. Large mixer blades had caused a severe erosion the tanks' structure. The time was of the essence because of the rainy season.

- * Damaged Concrete. ,
- * Concrete rebuilt with Belzona 4124. ,
- * Concrete coated with Belzona 5811. ,
- * Belzona Alumina Tiles System installed: Belzona 5811 as a base coat, Belzona 9811 and Belzona 1812 (as a grouting compound). ,
