Belzona Repair of Rail Print Interface on a Single Point Mooring Turret

ID: 7643

Industry: Marine

Substrate: ABS EH36 (normalized carbon steel)

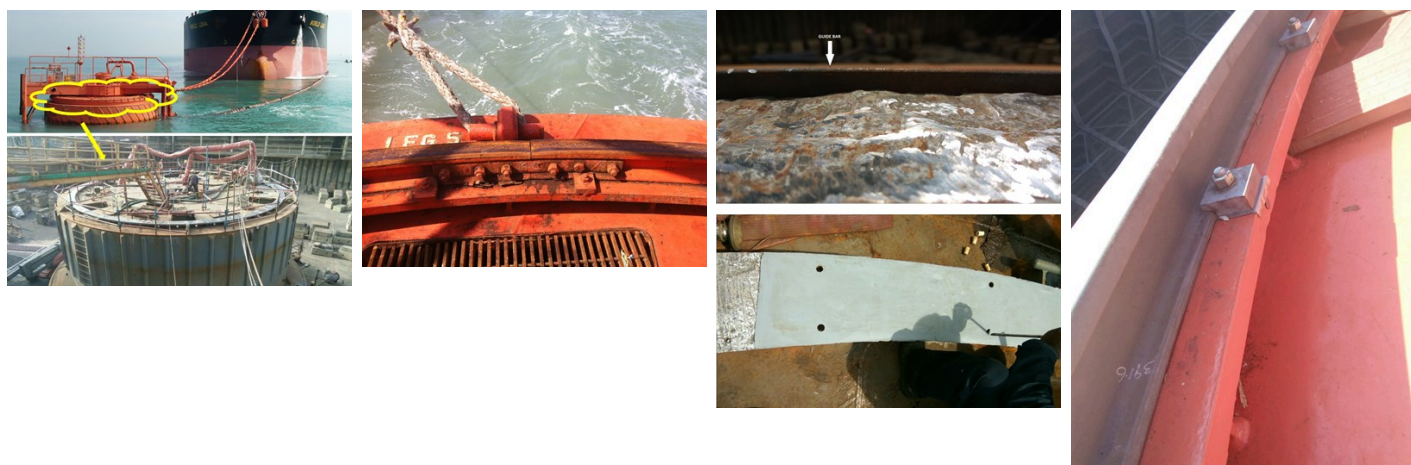
Photograph Descriptions

Severe pitting, galvanic and crevice corrosion on the rail support flange. Welding was not an option due to the location of the damage and the need for the surface to be accurately flat for the proper sitting of the rails.

- * Single Point Mooring Buoy and problem area. ,
- * Details of the pitting/crevice corrosion underneath the rail. ,
- * Surface preparation and application. ,
- * Completed application. ,

The surface preparation was carried out by power brushing and grinding deep crossed pattern grooves. Application was done manually with Belzona applicators, plugging the holes where the rails will be bolted to the structure. Leveling of the surface was done with a flat plate segment and side flat guide bars with a width of about 175 mm placed at the rail print area for leveling and

for flatness check.
