BELZONA 5811 FOR NEUTRALIZATION BASINS AT A COAL FIRED POWER PLANT

ID: 7647

Industry: Power
Application: TCC-Tanks and Chemical Containment Areas
Substrate: Concrete
Products: * Belzona 4111 (Magma-Quartz),
* Belzona 5811 (Immersion Grade),

Customer Location: Florida, USA
Application Date: December 2017

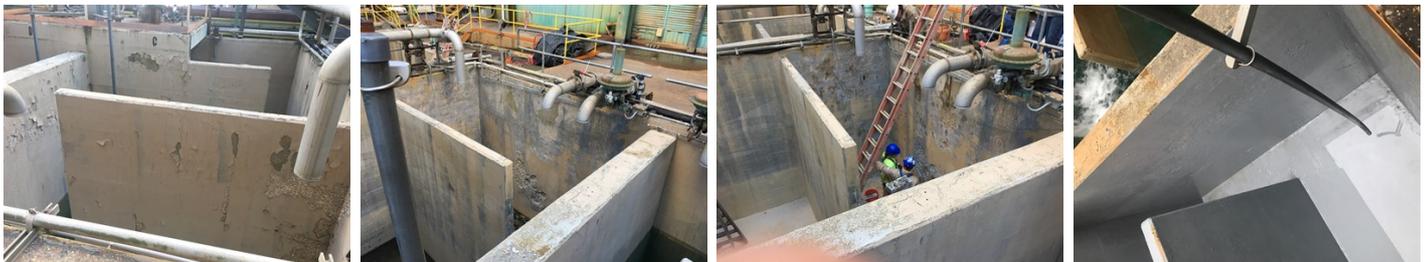
Photograph Descriptions

The chemical neutralization of the water that goes back into the river from this coal fired power plant takes place in four concrete neutralization basins. These basins had been coated with Belzona 4111 and over-coated with two coats of Belzona 5811 about 25 years ago. Gradually over the years the chemical attack had eroded some of the product. There was peeling of the walls and some places were down into the concrete substrate.

* 1. Neutralization basins after 25 years of the Belzona System.
2. The condition after pressure washing and brush blasting to remove all loose materials. Most of the substrate was in a good condition at that point.
3. Application of Belzona 4111, building up in layers to repair the holes in the concrete.
4. This is the first coat of Belzona 5811. ,

Belzona 4111 was built up in layers to fill in the holes in the concrete. Belzona 5811 was applied by brush and roller on a two coat system. The application was carried out in accordance with a modified version of TCC-9 and TCC-15.
