# BELZONA REPAIRS VULCANIZED RUBBER LINED PUMP

ID: 765

Application: SHM-Solids Handling Machinery

Customer Location: Chemical Plant, Italy

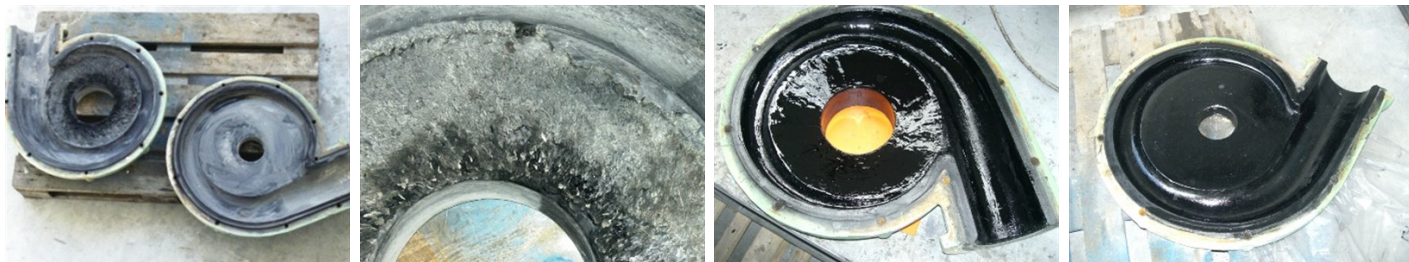
A large area of the rubber had been eroded away.

\* Pump body before application , \* Close up of damaged rubber , \* Upper body after application , \* Lower body after application ,

The application was carried out in accordance with Belzona System Leaflet SHM-11.

Belzona Elastomer outlasted the original rubber and allowed localized repairs to be carried out on site without having to return the pump for re-vulcanizing.
