# BELZONA GIVES A NEW LIFE TO A PAPER MILL PUMP

Industry: *Pulp & Paper*  
Application: *CEP-Centrifugal Pumps*  
Substrate: *Cast Iron*  
Products: *\* Belzona 1311 (Ceramic R-Metal) ,*  
*\* Belzona 1321 (Ceramic S-Metal) ,*

An old pump at a paper mill plant.

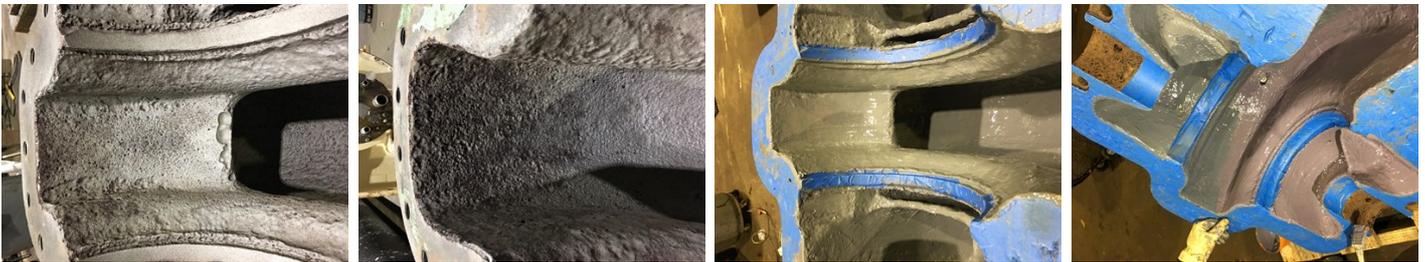
*The interior of the pump metal was severely pitted and the efficiency was compromised. This pump was slated to be scrapped because it was in a bad shape. The replacement pump did not arrive in time so the decision was made to try to salvage this pump using Belzona.*

- \* 1. Pitting and degradation of the pump after it was blasted with Black Beauty. ,
- \* 2. Before the product application ,
- \* 3. The metal rebuilt and coated ,
- \* 4. Two coats of Belzona 1321 applied over Belzona 1311. ,

Substrate was grit blasted with Black Beauty and then following the Manufacturer's Instructions for Use, a Belzona applicator was used to apply Belzona 1311 to rebuild and smooth out the damaged metal substrate. Belzona 1321 was then applied by a stiff bristle brush in two coats. The application was carried out in accordance with Belzona System Leaflets CEP-3 and CEP-5.
