# BELZONA SUPERWRAP II SAVES LEAKING SOUR CRUDE TANK

Industry: Oil & Gas  
Application: TCC-Tanks and Chemical Containment Areas

Customer Location: Florida, USA  
Application Date: October 2017

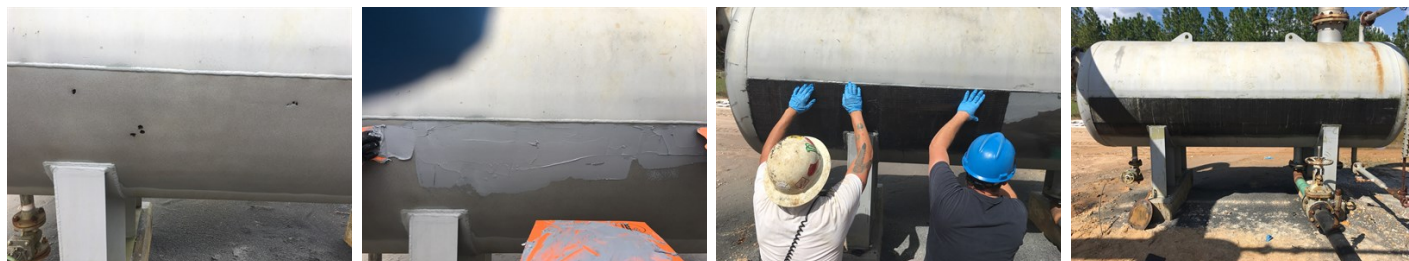
The sour crude tank started leaking and the production had to be shut down. Originally there were 3 holes discovered leaking in the tank. The Customer was afraid blasting would cause more holes along the liquids line. There was no money in the budget for a new tank but they were shut down and had to do something quickly.

- \* 1. More than the original 3 holes were discovered after blasting with Black Beauty. ,
- \* 2. Belzona 1111 is being applied to fill the holes and reinforce the area. ,
- \* 3. SuperWrap II is applied by the customer's crew in two coats along the liquids line. Each coat is applied in a different direction. ,
- \* 4. Finished tank after the Customer put the tank back in service. ,

The application was carried out in accordance with TCC-5 Belzona System Leaflet. To seal the leaks and offer the tank some mechanical reinforcement, it was decided to do a strip of SuperWrap II patch all along the side of the 10' tank. Belzona 1111 was used to patch the holes and reinforce the tank, applied by a Belzona Applicator. Two layers of SuperWrap II were applied, one

perpendicular and one horizontal to repair the tank.
