BELZONA RE-COATS A LARGE GOULDS PUMP IN A PAPER MILL

ID: 7652

Industry: Pulp & Paper
Application: CEP-Centrifugal Pumps
Substrate: Cast Iron
Products: * Belzona 1311 (Ceramic R-Metal) ,
* Belzona 1321 (Ceramic S-Metal) ,

Customer Location: Florida, USA
Application Date: May, 2017

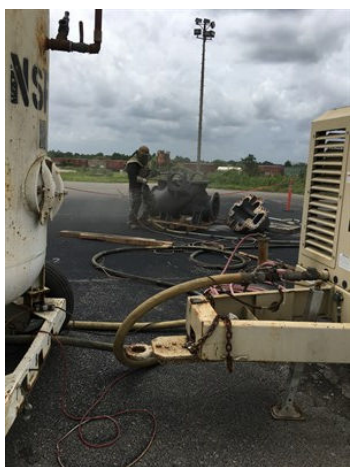
- * 1. Blasting out in the nn-house contractor's blast yard. ,
- * 2. Bringing in the pump with an overhead crane. ,
- * 3. Application complete. ,
- * 4. Application complete. ,

Old coating was blasted off with Black Beauty to reach the cleanliness profile required by Belzona. Belzona 1311 was applied to smooth out all rough areas. Two coats of Belzona 1321 were applied with brushes. The application was carried out in accordance with CEP-3 and CEP-5 Belzona System Leaflets.
