BELZONA SUPERWRAP II SEALS THROUGH CRACKS ON A 90 DEGREE FLANGE FOR A CHILLER PUMP

ID: 7654

Customer Location: Florida, USA
Application Date: Summer, 2017

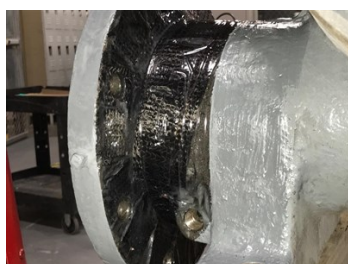
The Customer attempted to repair the cracks. However, leaks still existed after the pump was reinstalled onto the chiller return line and tested. The new solution of Belzona Superwrap II was suggested for the 90 degree flange.

- * 1. Customer's attempted repair. ,
- * 2. Superwrap II application on the outside of the flange. ,
- * 3. Superwrap II application on the inside of the flange. ,
- * 4. Pump reinstalled and working after 4 months of operation nonstop and still working with no leaks. ,

Surface was prepared with abrasive blast clean following the Manufacturer's Instructions for Use. The ends of the through cracks were drilled and Belzona 1111 was applied into the inside of the cracks. Once Belzona 1111 set up and still within the overcoat time, 4 wraps of Belzona SuperWrap II were applied on the inside of the 90 degree bend of the flange and the outside to re-enforce it for strength. The application was carried out in accordance with a modified version of CEP-6 Belzona System Leaflet.
