# NEW BELZONA COATING FOR TWO SIDE-BY-SIDE CONDENSER TANKS

ID: 7657

Industry: *General Industry*  
Application: *TCC-Tanks and Chemical Containment Areas*  
Substrate: *Steel*  
Products: *\* Belzona 5892 ,*

Customer Location: *Florida, USA*  
Application Date: *October 2017*

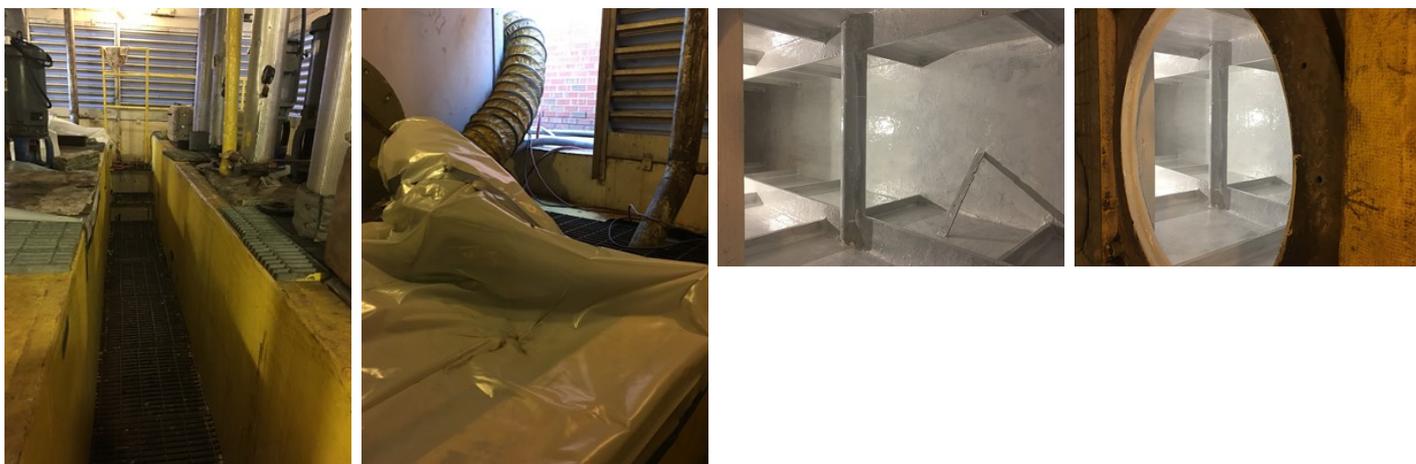
*The existing coating in the tanks was having some problems with delamination. The owner wanted them to be coated with Belzona. These tanks held water around 198 F. They had no agitation.*

- \* 1. Two condenser tanks, side by side. ,
- \* 2. Blasting the tanks using Sponge Jet. ,
- \* 3 & 4. Newly re-coated tanks with two coats of Belzona 5892. ,

The tanks were both blasted using the Sponge Jet method to control dust. Then two coats of Belzona 5892 were applied by hand using a brush and following the Manufacturer's Instructions for Use. The application was done in accordance with Belzona System Leaflet TCC-5.
